# Manhole Inspection Summary

Manhole # S25CC1003MH

Insp Date: **1/24/07 2:40 PM**

**Location** Address: **3708 37TH ST**

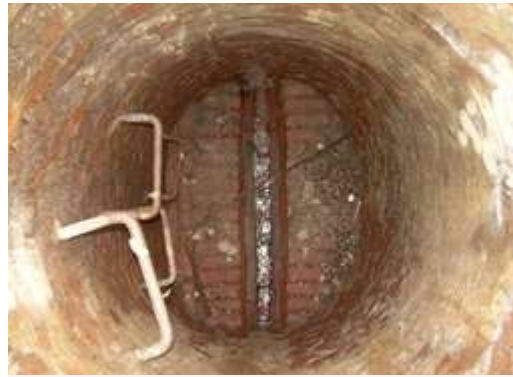
Top View

Corroded steps. Evidence of surcharge - Bench debris.

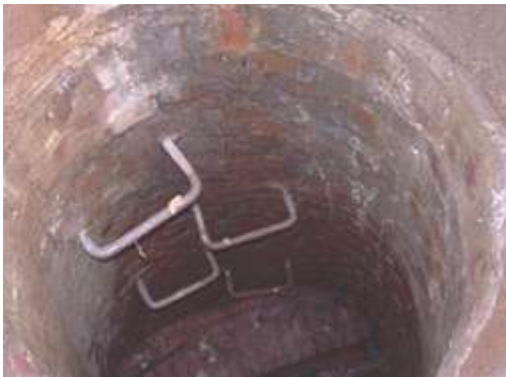
Defect

Frame leaks. Adjustment deterioration and infiltration - other side.

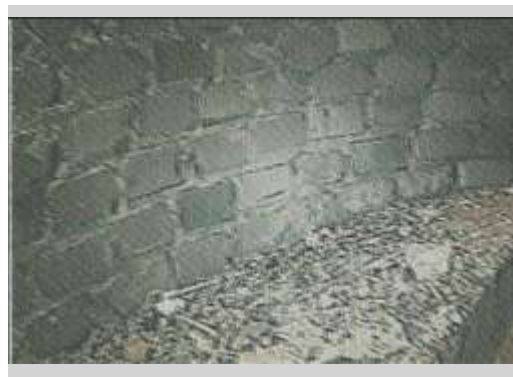
Defect

Barrel deterioration and infiltration. Bench debris.

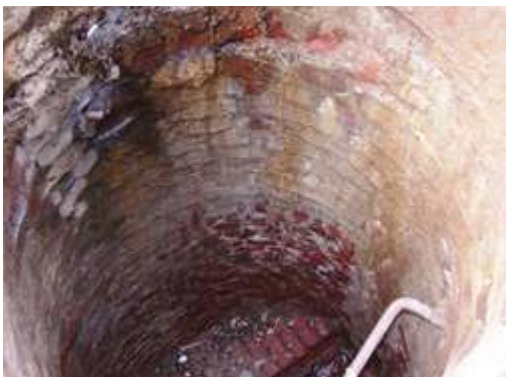
Defect

Frame leaks. Adjustment deterioration and infiltration.

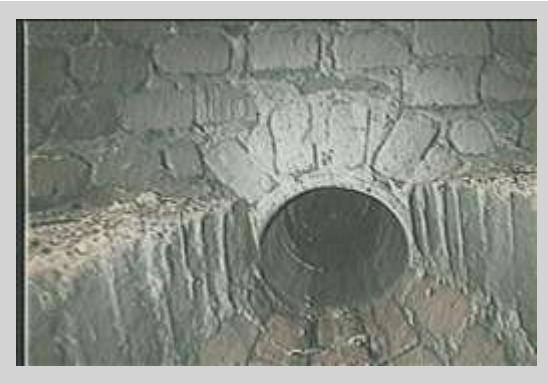
### 8 in. Circular Gravity Sewer Pipe Out @ 12 O'Clock

Barrel deterioration and infiltration. Channel deterioration.

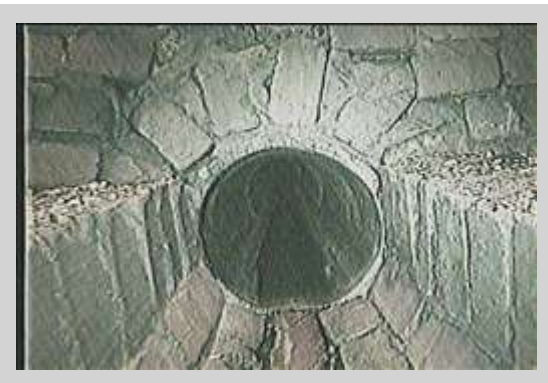
### 8 in. Circular Gravity Sewer Pipe In @ 6 O'Clock

Barrel deterioration and infiltration. Channel deterioration.
